Name Of Dam: UPPER SOUTH LAKE DAM
Location: FAIRFAX COUNTY
Inventory Number: VA. 05913

PHASE I INSPECTION REPORT

NATIONAL DAM SAFETY PROGRAM

DEWARD M. MARTIN & ASSOCIATES
WILLIAMSBURG, VIRGINIA
AUGUST, 1979

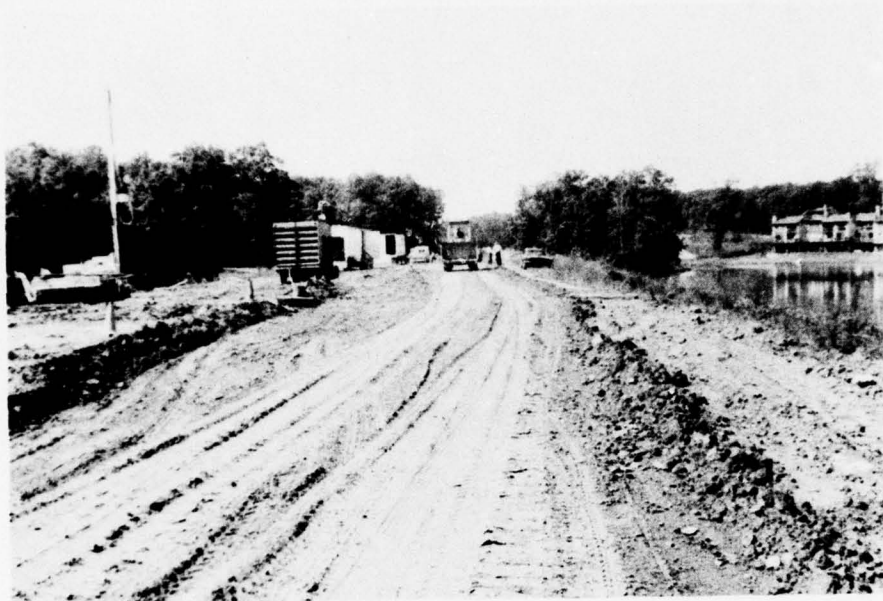
Top of Dam

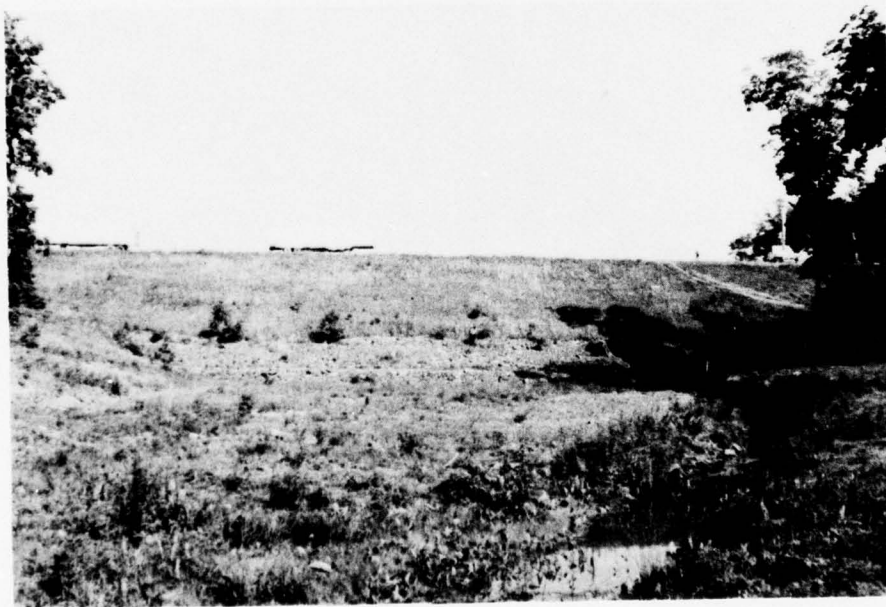
Downstream Face of Dam

At both abutments, runoff has started erosion where the fill meets natural ground. The area downstream of the dam was damp for 200 to 300 feet although no flow was observed.

3.2 Evaluation: The areas where gullies were detected and other signs of erosion should be repaired to prevent further deterioration and action should be taken by the owner to eliminate the vehicular traffic on the embankment and abutments. A grouting program was in progress at the time of the inspection to eliminate the seepage described above, however, it was not complete and the seepage was still occurring.

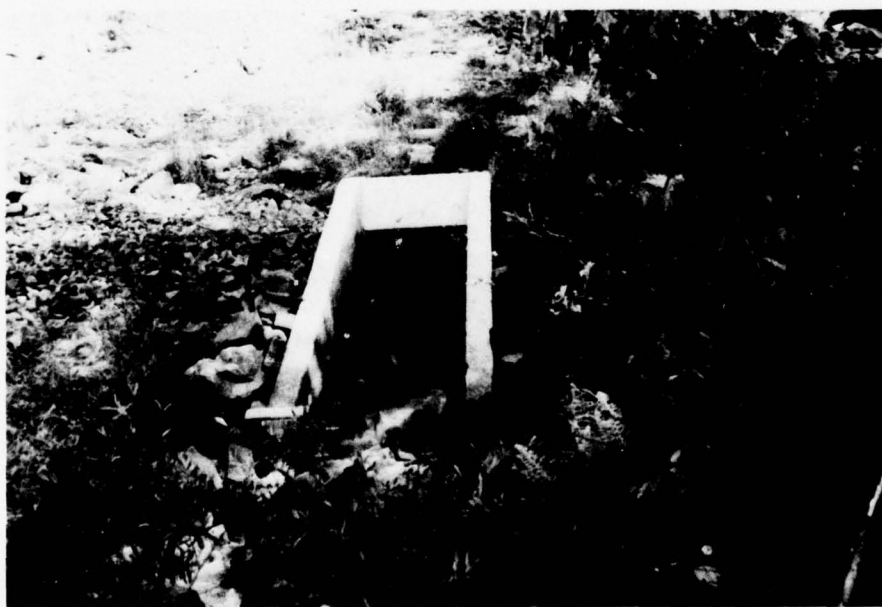
PHOTOGRAPH NO. 2
Discharge Box Culvert

4.2 Maintenance of Dam: Mowing is done by the owner. There is presently a grouting contract in progress to stop the seepage through the embankment and foundation material. Surface marks of cars or motorcycles, reported to be evident, were removed at the time of inspection. The dirt road at the left abutment should be removed or barricaded. The riser structure and the 4-foot box culvert appeared to be in good condition. The outlet for the box culvert, at the downstream toe of the dam, was partially blocked by debris which should be removed.

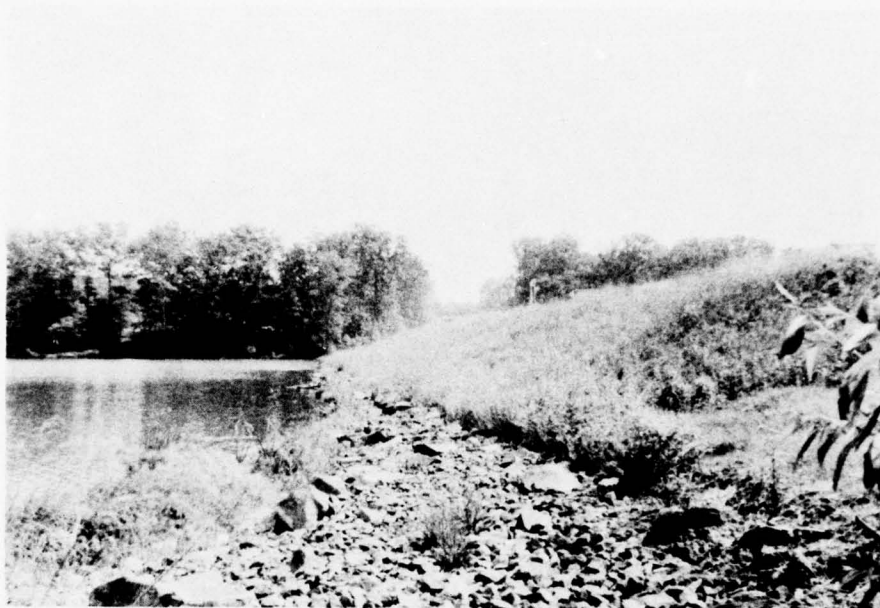
PHOTOGRAPH NO. 3
Upstream Face of Dam

*3.1.2.1 The dam appeared to be in good condition. The crest is now serving as an unpaved road. There is no indication of settlement of the crest of the dam. The upstream slope was covered with grass and weeds. Small gullies were observed at several locations on the downstream slope, mainly near the center of the slope and adjacent to the road at the left abutment. These appeared to be created by vehicular traffic. Some sloughing was associated with these gullies indicating possible settlement and/or seepage. In some places, sand was noted on top of the riprap.
